**Historic District Review Committee
Staff Report
Date of Meeting: February 13, 2012
CAPP2012-0002
Historic District: Taylorstown
Project Planner: Lauren Murphy**

CAPP 2012-0002 Tedd & Dana Durden: Taylorstown Store and Frame Shop Alterations. PIN # 341-103-295.

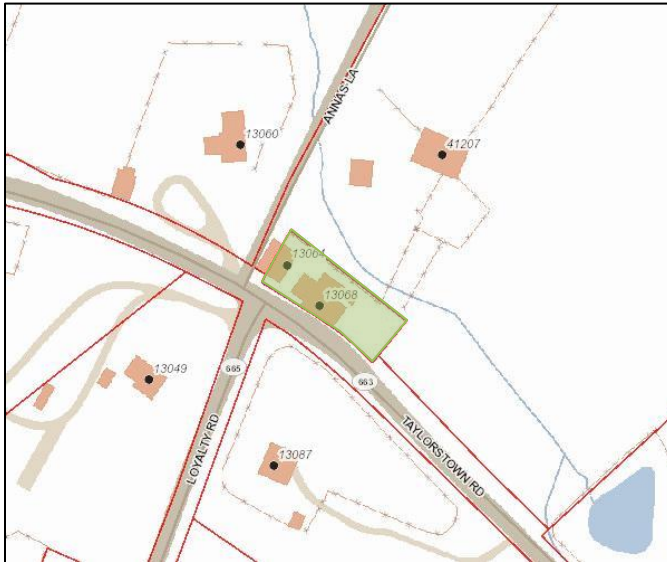
Figure 1: Subject Property, 13068 Taylorstown Road

The subject property is located at 13068 Taylorstown Road on approximately .25 acres in the Taylorstown Historic District. Two buildings are located on the property – the Taylorstown Store (store) and Frame Shop. Both buildings front on Taylorstown Road at the intersection with Loyalty Road.

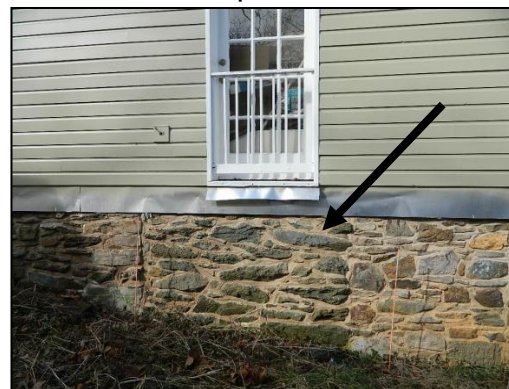
Photo 1: East Elevation Frame Shop with fieldstone veneer. Note that it is still differentiated from the foundation

Fieldstone veneer is proposed to infill openings in the stone foundation of the Frame Shop. It is noted that based on a staff site visit on January 20, 2012, one opening on

the east (side) elevation has already been filled with the proposed stone veneer. The north (rear) elevation remains entirely open and the foundation creates piers on either side. The applicant originally received approval under CAPP 2009-0016 to infill these voids with vertical boards, parged concrete block, or painted brick. The larger opening on the rear elevation will have a vertical board door on one side to allow access beneath the building.

3. The Guidelines support the use of stone as a foundation material. The proposed fieldstone nearly matches the existing stone but is visually differentiated from the original foundation. Infilling the foundation openings with stone and mortar matching the existing color, size, texture, tooling, and joint size meets the Guidelines. The vertical board door on the rear elevation also meets the Guidelines for materials.

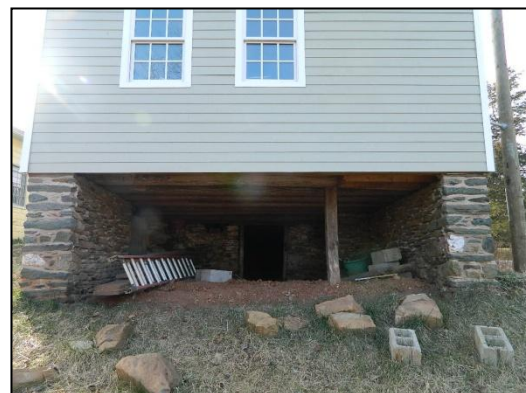
Photo 2: Opening on rear elevation of Frame Shop

Staff finds that the infill of the remaining void on the rear elevation foundation with fieldstone and a vertical board door is consistent with the Guidelines provided that the color, size, texture, tooling and mortar joint size will match that of the existing stone work as closely as possible. For clarity, a condition to this effect is suggested.

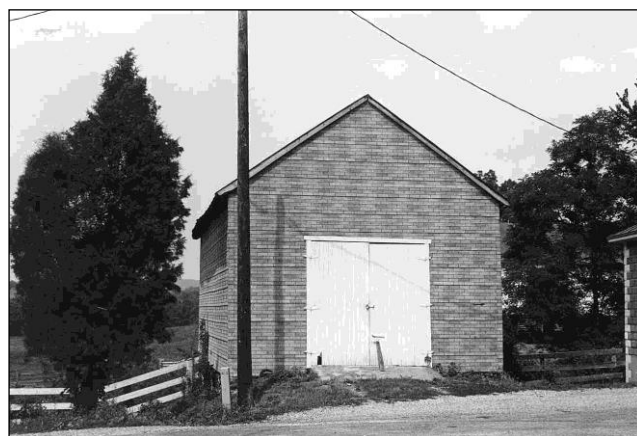
Photo 3: Frame Shop in 1974. Note absence of front porch (Source: VDHR).

to the front elevation of the Frame Shop sometime after the mid 1970s (see photo 3) and is therefore not an historic element of this structure.

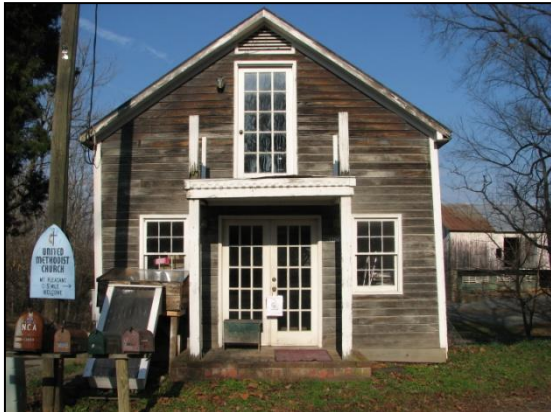
Photo 4 (at left): Frame Shop in 2009 with deteriorating front porch

The applicant has currently removed the porch, visible in photo 5, and is proposing to construct a new porch with a gable roof in the same general location. The proposed porch would require the conversion of the removal of the second story door which the applicant proposes to convert into a double-hung window. The previous porch was a flat roof that provided a small balcony accessible from the second story door visible in photo 4.

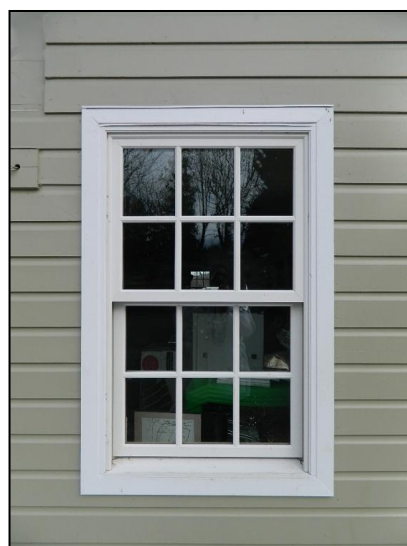
Photo 6: Replacement window, front elevation

for the replacement windows and doors. During previous site visits and evaluations, the replacement windows were determined to be vinyl or vinyl clad however, the applicant has submitted information indicating that the windows are aluminum clad. **The HDRC should clarify the material of the replacement windows at the meeting although staff notes that neither vinyl nor aluminum clad windows are an appropriate replacement for wood.**

The replacement of wood windows and doors with an alternative material is not supported by the Guidelines. The Guidelines clearly advocate for repair and replacement in-kind of existing windows in historic buildings and advocate replacement only in cases where the window or elements of the window are beyond repair (*ABOT Guidelines, Guidelines for Existing Structures, Windows, page 110, Guidelines 1, 3, 5, and 6*). The SOJ indicates that the wood windows were not able to be repaired; in which case the Guidelines would support replacement with in-kind wood windows after a survey of the windows was conducted and documented to show their deterioration (*ABOT Guidelines, Guidelines for Existing Structures, Windows, page 105, sidebar*). The Guidelines state that three-part SDLs should be utilized for replacement windows (*ABOT Guidelines, Guidelines for Existing Structures, Windows, page 110, Guideline 7.b.ii*). The proposed windows are 6/6 with applied 7/8" muntins. The windows do not utilize an integral spacer bar which is not consistent with the Guidelines. Similarly, the Guidelines advocate the repair of historic doors and only support replacement of doors with "new or salvaged doors of the same size, design, material and type" (*ABOT Guidelines, Guidelines for Existing Structures, Doors, page 102, Guidelines 1 and 2*). A wood door remains on the east elevation of the frame shop. This door should be retained and repaired or replaced in-kind if necessary. **The replacement of wood windows and doors with vinyl or aluminum clad windows and the use of fixed muntins without an integral spacer bar do not meet the Guidelines for existing structures.**

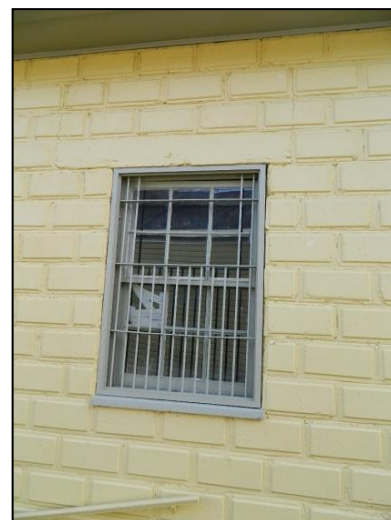
Photo 7: West elevation window proposed for replacement.

The applicant proposes to replace two metal store windows with fixed panes of glass behind the existing metal window bars. The first window is located on the west elevation of

the first addition to the store and the second is located on the north (rear) elevation of the store. The existing windows are 6/6 double hung. As with the replacement windows proposed for the Frame Shop, the Guidelines support repair and replacement in-kind. The applicant's SOJ indicates that they cannot obtain replacement parts for the windows. The proposed fixed pane windows for the Store will be partially shielded by the metal bars and are not located on primary elevations. The window on the rear elevation will not be visible from the public right-of-way. In this case, it may be appropriate, if the windows are beyond repair, to replace them with fixed panes behind the metal bars since the fenestration of these elevations will appear the same.

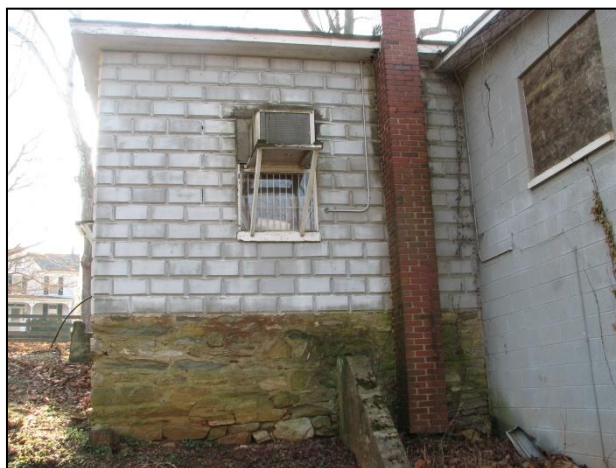
Photo 8: North elevation window proposed for replacement (photo taken in 2009)

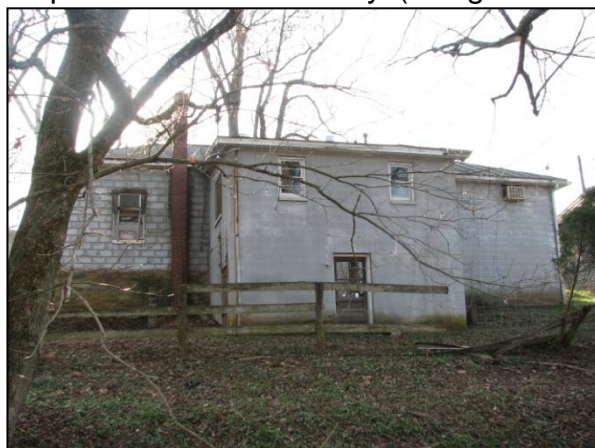
Photo 9: Rear (north) elevation with chimney in existing location (2009). Conditions of approval for CAPP 2009-0016 require the relocation of the chimney to the NW corner of the original block.

The December 2009 staff report identified the chimney as contemporary with the construction of the store and a character defining characteristic of the building. The ABOT Guidelines specifically support maintaining existing historic chimneys and identify removing historic chimneys as an Inappropriate Treatment. If they are removed, then the Guidelines promote preserving the exterior portion of the chimney (using interior bracing it if necessary) to retain the original appearance of the building. Removing the brick chimney does not meet these Guidelines (ABOT Guidelines, Guidelines for Existing Structures: Chimneys, Inappropriate Treatment 1 and Guidelines 1 and 5, p. 97).

The HDRC previously required that that the chimney be retained but allowed for it to be relocated to the North West corner of the store as a condition of CAPP 2009-0016. The applicant's SOJ indicates that many of the original bricks will need to be replaced with new bricks and/or stones if the chimney is rebuilt. While the Guidelines

support retaining historic chimneys, the relocation of the chimney from its original location risks additional damage to the historic bricks. This, in combination with the need for new materials, erodes the context of the historic chimney and in this instance, removal of the chimney may be acceptable.

If the HDRC does not approve the removal of the chimney, the applicant is proposing to reconstruct the chimney as conditioned but is requesting approval to utilize stone at the base of the chimney and historic bricks on the upper portion. The Guidelines support the use of brick or stone as the exterior material for new chimneys and note that the use of stone to the height of the foundation or first floor was a common practice in the construction of chimneys (ABOT Guidelines, Guidelines for Existing Structures, Chimneys, page 97, Guideline 7 and photo). If stone is utilized, it should emulate indigenous stone and match other stone approved for use in the project (ABOT Guidelines, Guidelines for Materials, Stone and Brick, page 129, Guideline 7). Replacement bricks should match the historic bricks as closely as possible in size, shape, color, bonding pattern. The mortar joint size and color should also match existing as closely as possible.
